Lake Borgne Drainage Canals Assessment

April 24, 2019

RE: Lake Borgne Drainage Canals Condition

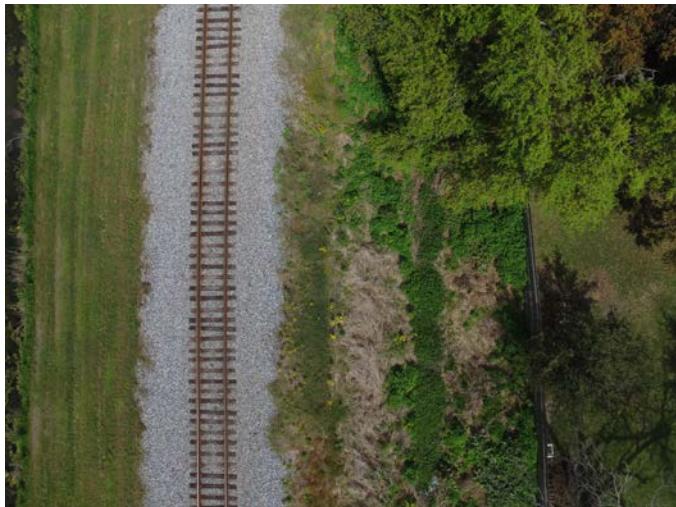
Alexander (East Railroad Ditch) runs parallel and East of Norfolk Southern RR for 5500 feet from West St. Bernard Hwy to Alexander Ave. at Benjamin St. in Arabi. The Ditch is in an area that has a reported history of flooding events. The Ditch is a small, shallow stream with moderate to heavy pond algae in pockets, with a poorly maintained channel and overgrowth on both banks.

Overall condition: Fair

Alexander (East Railroad Ditch); Visible overgrowth and poorly maintained

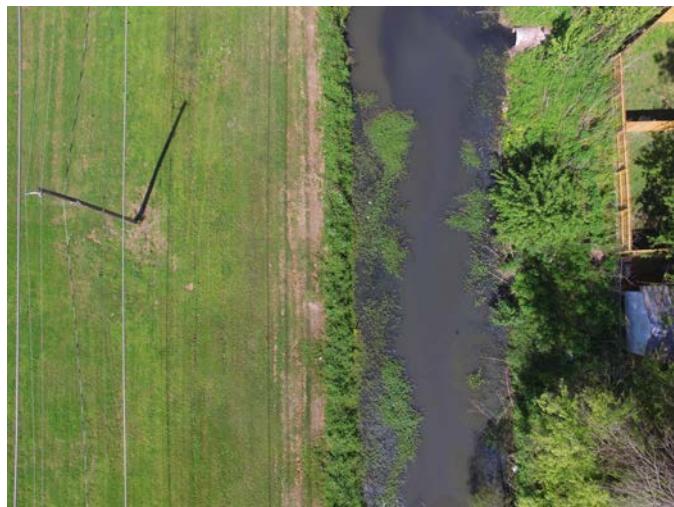
Pakenham North (Guichard Canal) runs parallel and Southeast of Pakenham Dr. for 5500 feet from W. Josephine St. to Florida Walk Canal in Chalmette. The Canal is in an area that has a reported history of flooding events. The Canal is a medium to large feeder canal. Significant pond algae pockets are visible. The canal appears adequately maintained.

Overall condition: Fair

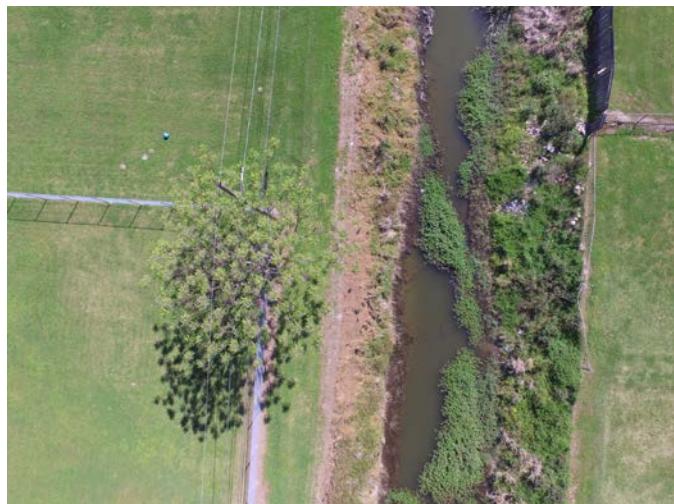
Schnell North (Eickes Canal) runs parallel and West of Schnell Drive for 4000 feet from W. Judge Perez Drive to Florida Walk Canal in Arabi. The Canal is in an area that has a reported history of flooding events. The Canal is a small to large canal. Overgrowth is visible on both banks. Pond algae is visible along both banks and in dense pockets.

Overall condition: Fair

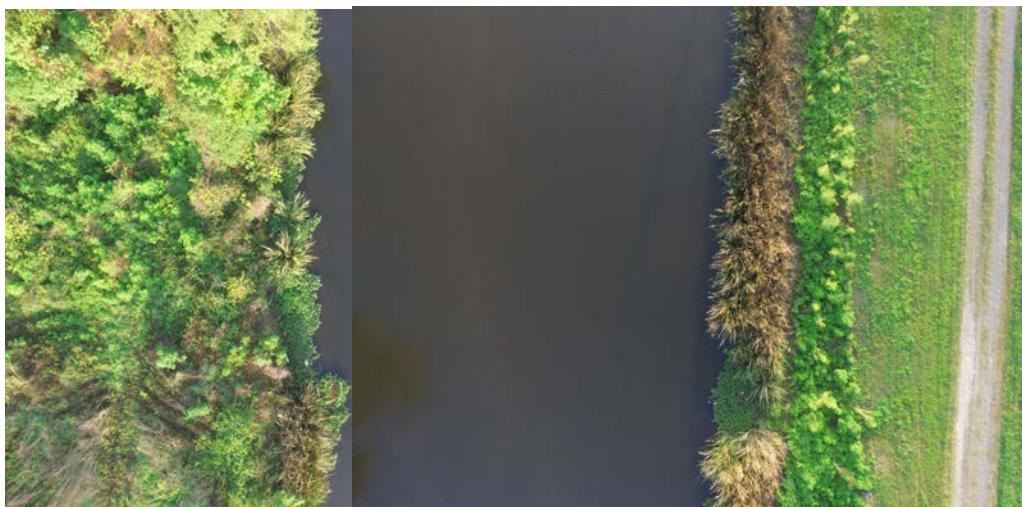
PS-4_02 (Forty Arpent Canal)

PS-4 02 (Forty Arpent Canal) runs parallel and Southwest of Chalmette Back Levee for 500 feet from Munster Boulevard to Jacob Drive in Meraux. The Canal is in an area that has a reported history of flooding events. The Canal is a large primary storage canal. Overgrowth is visible on both banks. Heavy trees overhang most of the southwest bank. The canal appears adequately maintained.

Overall condition: Fair

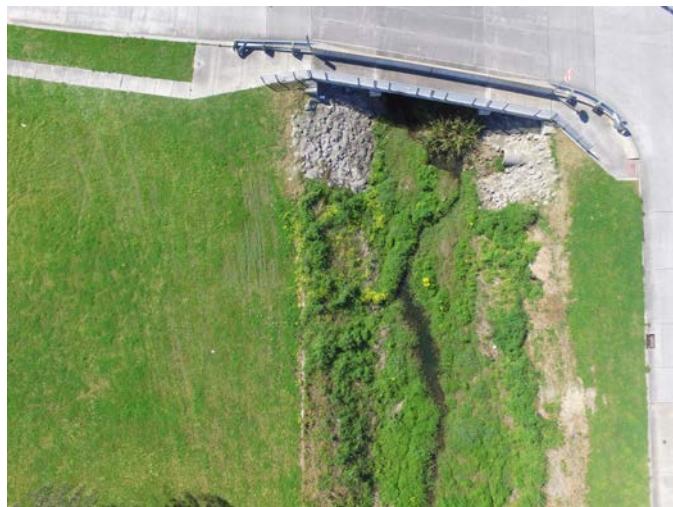
St. Avide (Corinne Canal) runs parallel and South of St. Avide Street for 3500 feet from Delambert Street to Gallo Drive in Chalmette. The Canal is in an area that does not have a reported history of flooding events. The Canal is a large, shallow canal. Overgrowth is visible on both banks. The channel is poorly maintained.

Overall condition: Fair

St. Avide (Corinne Canal); Visible overgrowth

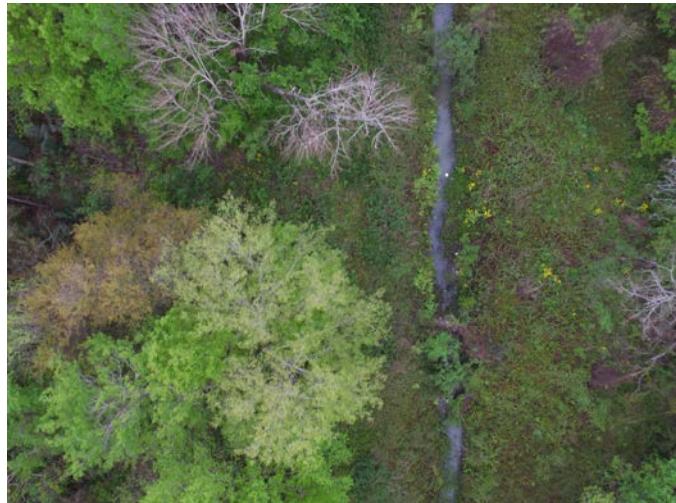
General Pershing (Violet Ditch) runs parallel and Northwest of Violet Canal for 2000 feet from General Pershing St. to JudgePerez Canal in Violet. The Ditch is in an area that does not have a reported history of flooding events. The Ditch is a small, shallow stream. Tree overgrowth is visible on both banks. The channel is poorly maintained.

Overall condition: Poor

General Pershing (Violet Ditch); Visible overgrowth, channel poorly maintained

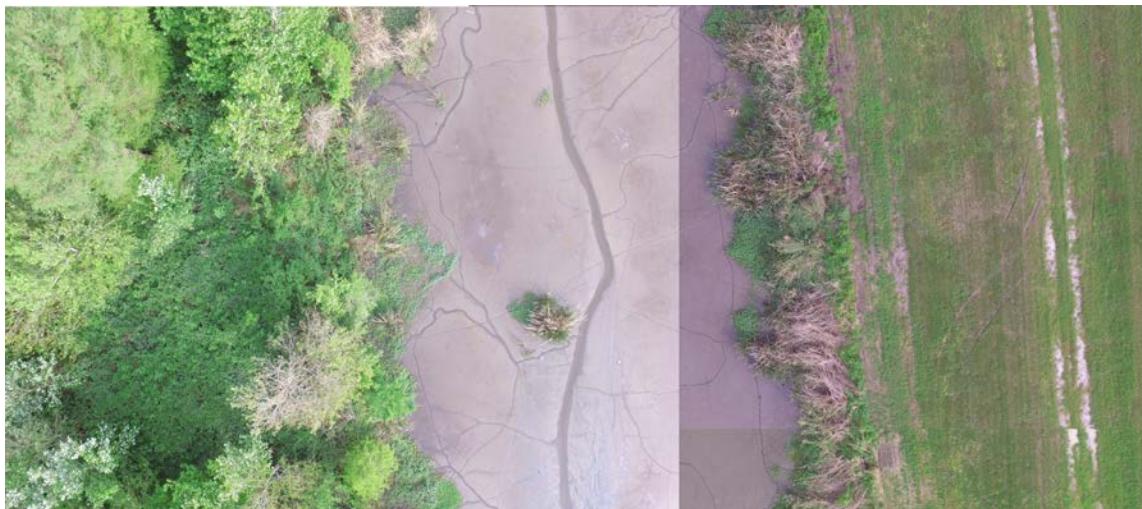
PS-4 01 (Forty Arpent Canal) runs parallel and Southwest of Chalmette Back Levee for 7000 feet from Violet Canal to Shannon Canal in Violet. The Canal is in an area that has a reported history of flooding events. The Canal is a large primary storage canal. The canal appears adequately maintained. Dense pockets of pond algae are visible on the northwest bank for half the canal length. Southeast half of the canal length is visibly very shallow. Heavy Overgrowth is visible on both banks. Heavy trees overhang the southwest bank.

Overall condition: Fair

PS-4_01 (Forty Arpent Canal); Southeast half visibly shallow, heavy overgrowth)

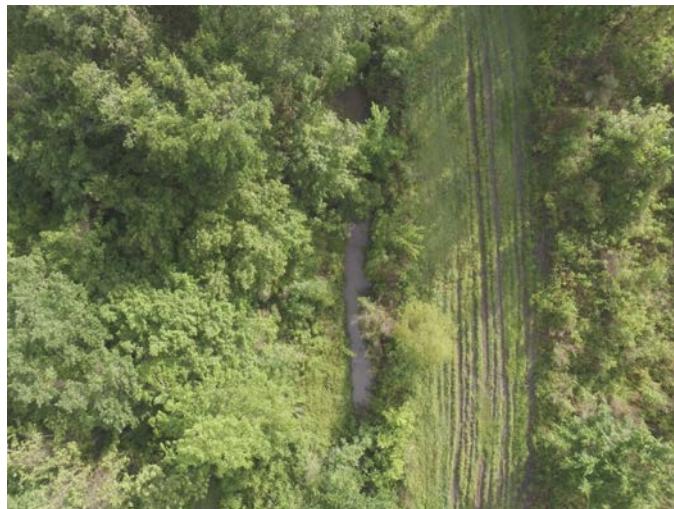
Violet (Violet Ditch) runs parallel and North of Lakewood Drive / Violet Canal for 3500 feet from E. Judge Perez Drive to Forty Arpent Canal in Violet. The Ditch is in an area that does not have a reported history of flooding events. The Ditch is a medium feeder canal. Thick overgrowth is visible on both banks. Dense trees are visible overhanging the northwest bank.

Overall condition: Poor

Violet (Violet Ditch); Thick overgrowth and extensive tree overhang

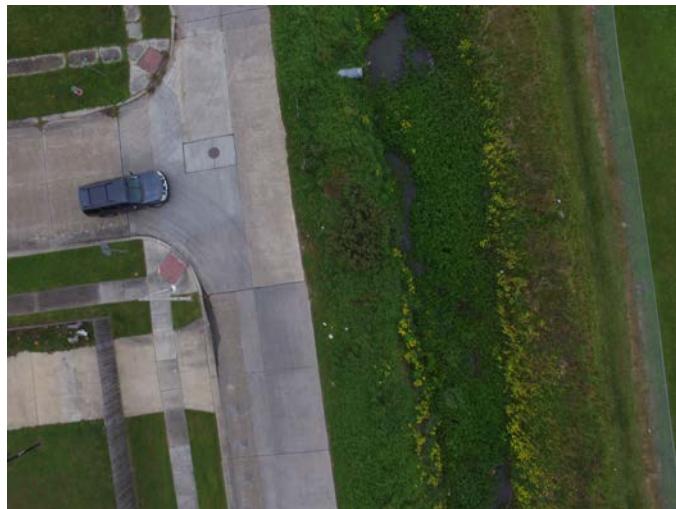
Green (Green Avenue Ditch) runs parallel and South of Green Ave. for 6000 feet from E. St. Bernard Hwy. to Centanni Canal in Poydras. The Ditch is in an area that does not have a reported history of flooding events. The Ditch is a small, shallow stream. Heavy trees overhang the south bank. Overgrowth is visible on both banks. The canal is poorly maintained.

Overall condition: Poor

Green (Green Avenue Ditch); Overgrowth, poorly maintained

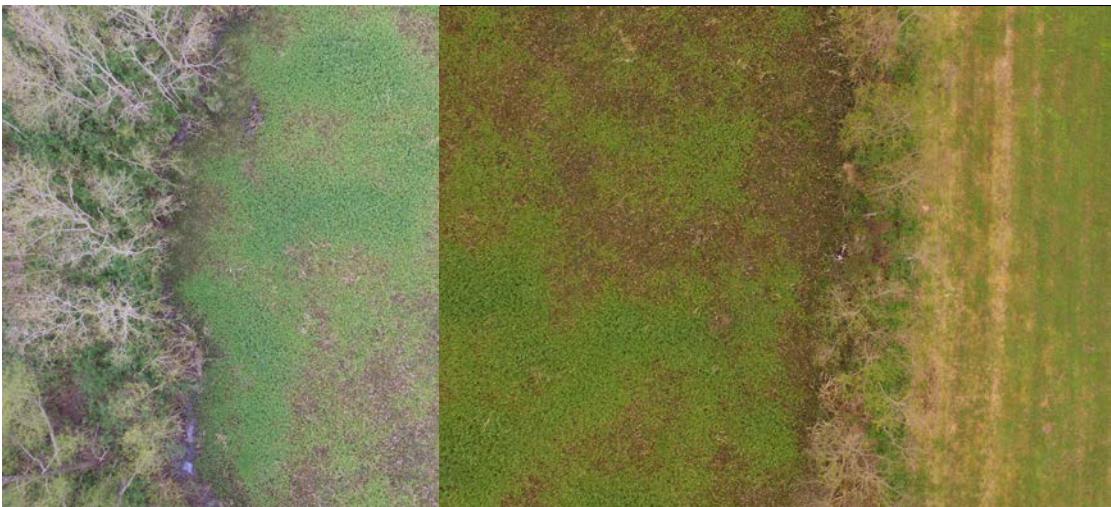
PS-8_09 (Forty Arpent Canal) runs parallel and South of Poydras Back Levee for 7000 feet from Floodside north canal to Rue Terre Aux Boeufs in St. Bernard. The Canal is in an area that does not have a reported history of flooding events. The Canal is a large primary storage canal. Heavy overgrowth and trees are visible on the south bank. Unbroken pond algae is visible through the entire reach.

Overall condition: Good

PS-8_09 (Forty Arpent Canal); Pond algae

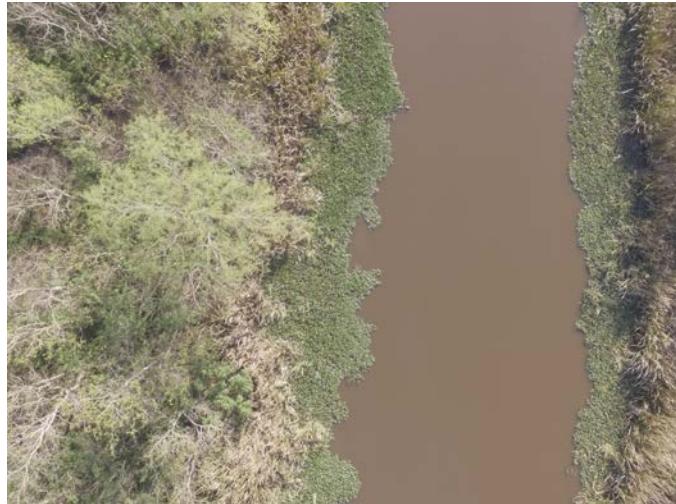
PS-8 03 (Twenty Arpent Canal) runs parallel and North of Hurricane Protection Levee for 11000 feet from Western Gas Road to PS-8 in St. Bernard. The Canal is in an area that does not have a reported history of flooding events. The Canal is a large primary storage canal. Heavy overgrowth and trees are visible on both banks. Moderate pond algae is visible throughout with some dense pockets. The canal appears adequately maintained.

Overall condition: Fair

PS-8_03 (Twenty Arpent Canal); Overgrowth

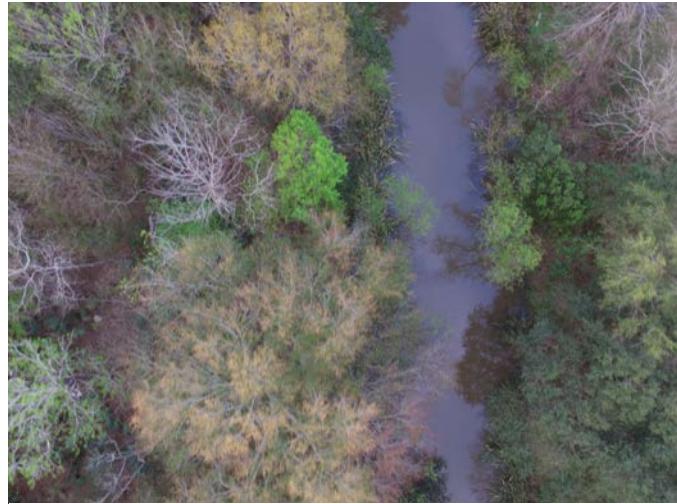
PS-8_06 (Twenty Arpent Canal) runs parallel and Northwest of Poydras Back Levee for 2000 feet from Bayou Road (LA 300) to LA 46 in St. Bernard. The Canal is in an area that does not have a reported history of flooding events. The Canal is a large primary storage canal. Heavy overgrowth and trees are visible on both banks. Moderate pond algae is visible throughout with some dense pockets. The canal is poorly maintained.

Overall condition: Poor

PS-8_06 (Twenty Arpent Canal); Overgrowth and poorly maintained
